Report Number: 214-TRC-04-008

Safety Compliance Testing For FMVSS 214

Side Impact Protection

2005 Subaru Legacy 4-door

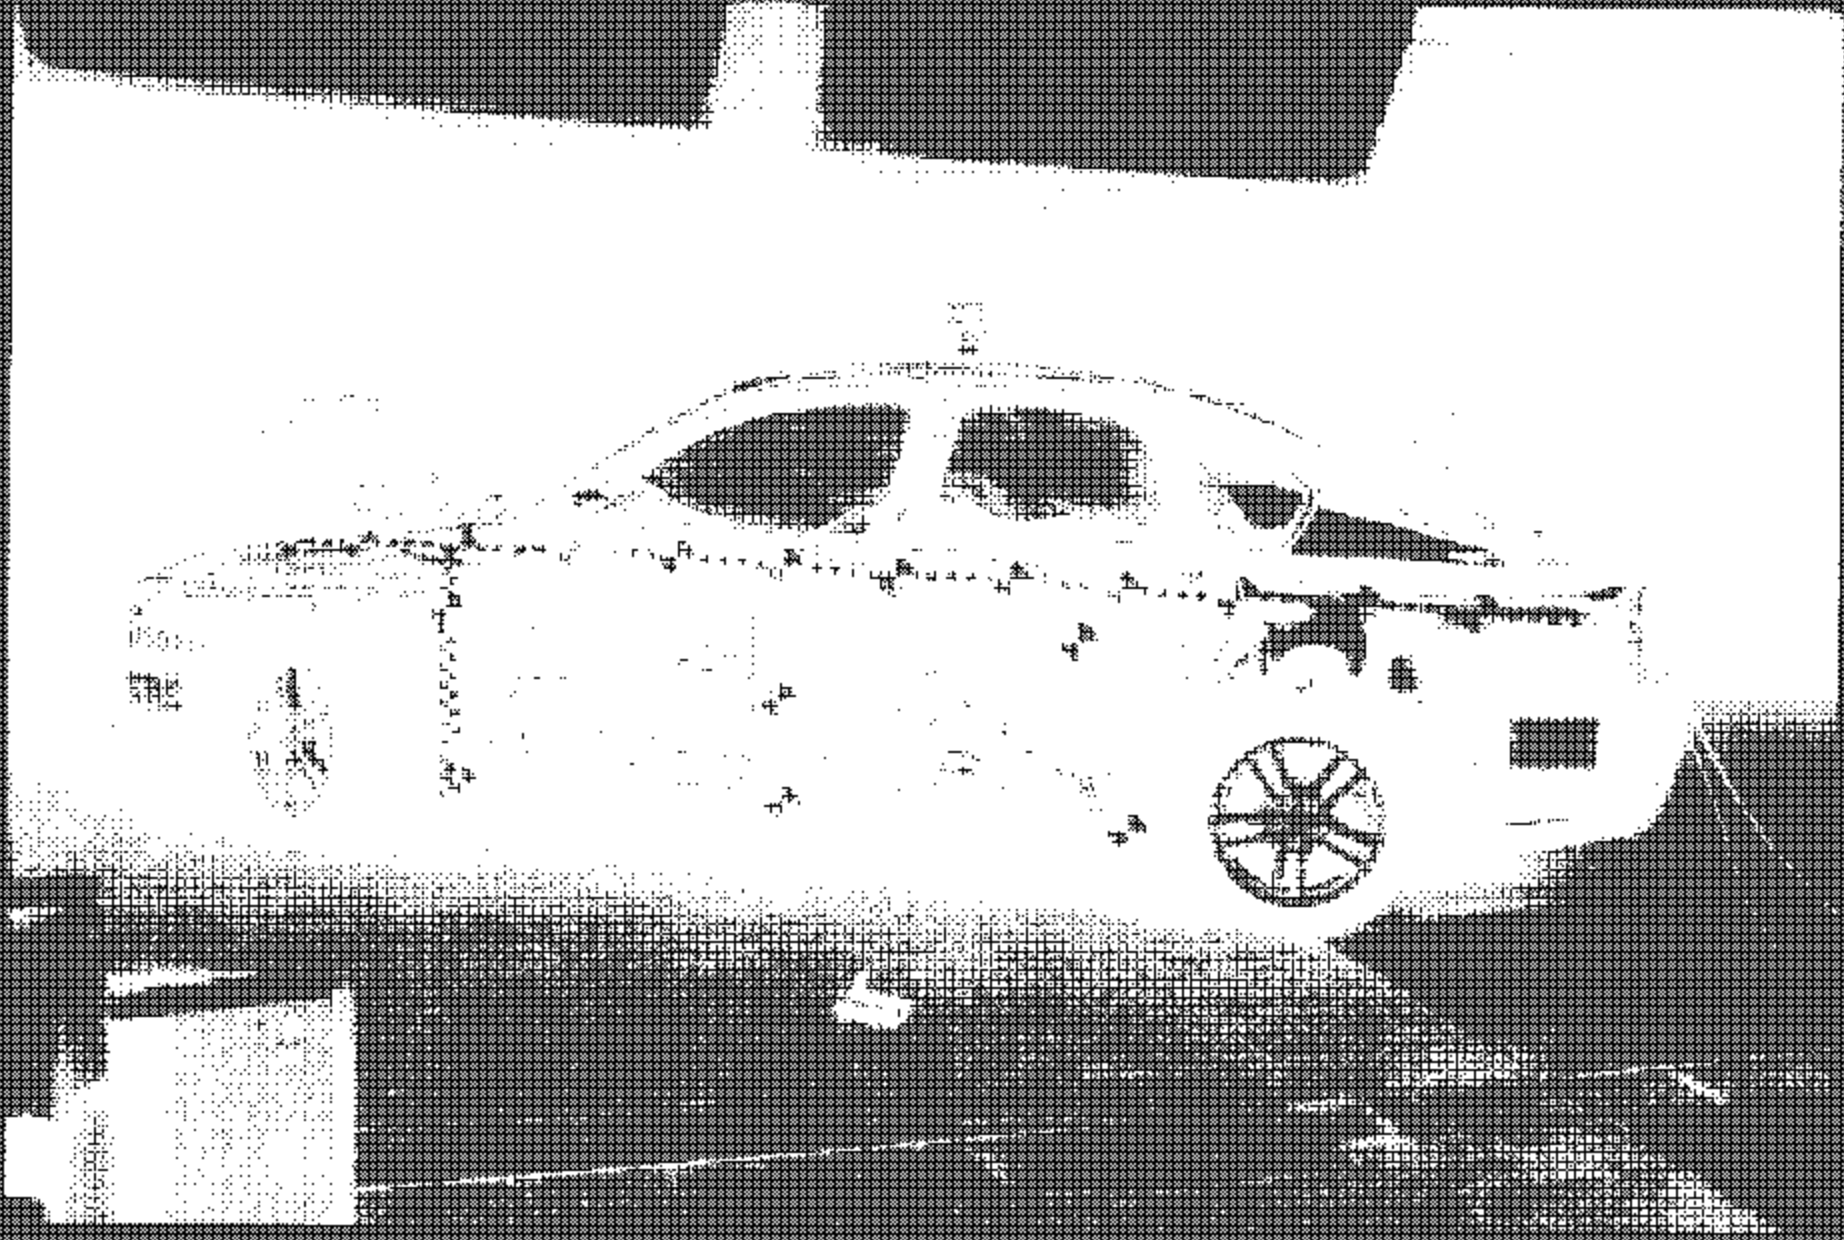
Figure A-4 Post-Test Impacted Side View of Dead Vehicle

Window: Left side windows broken

Full length of induced damage was 2100 mm.

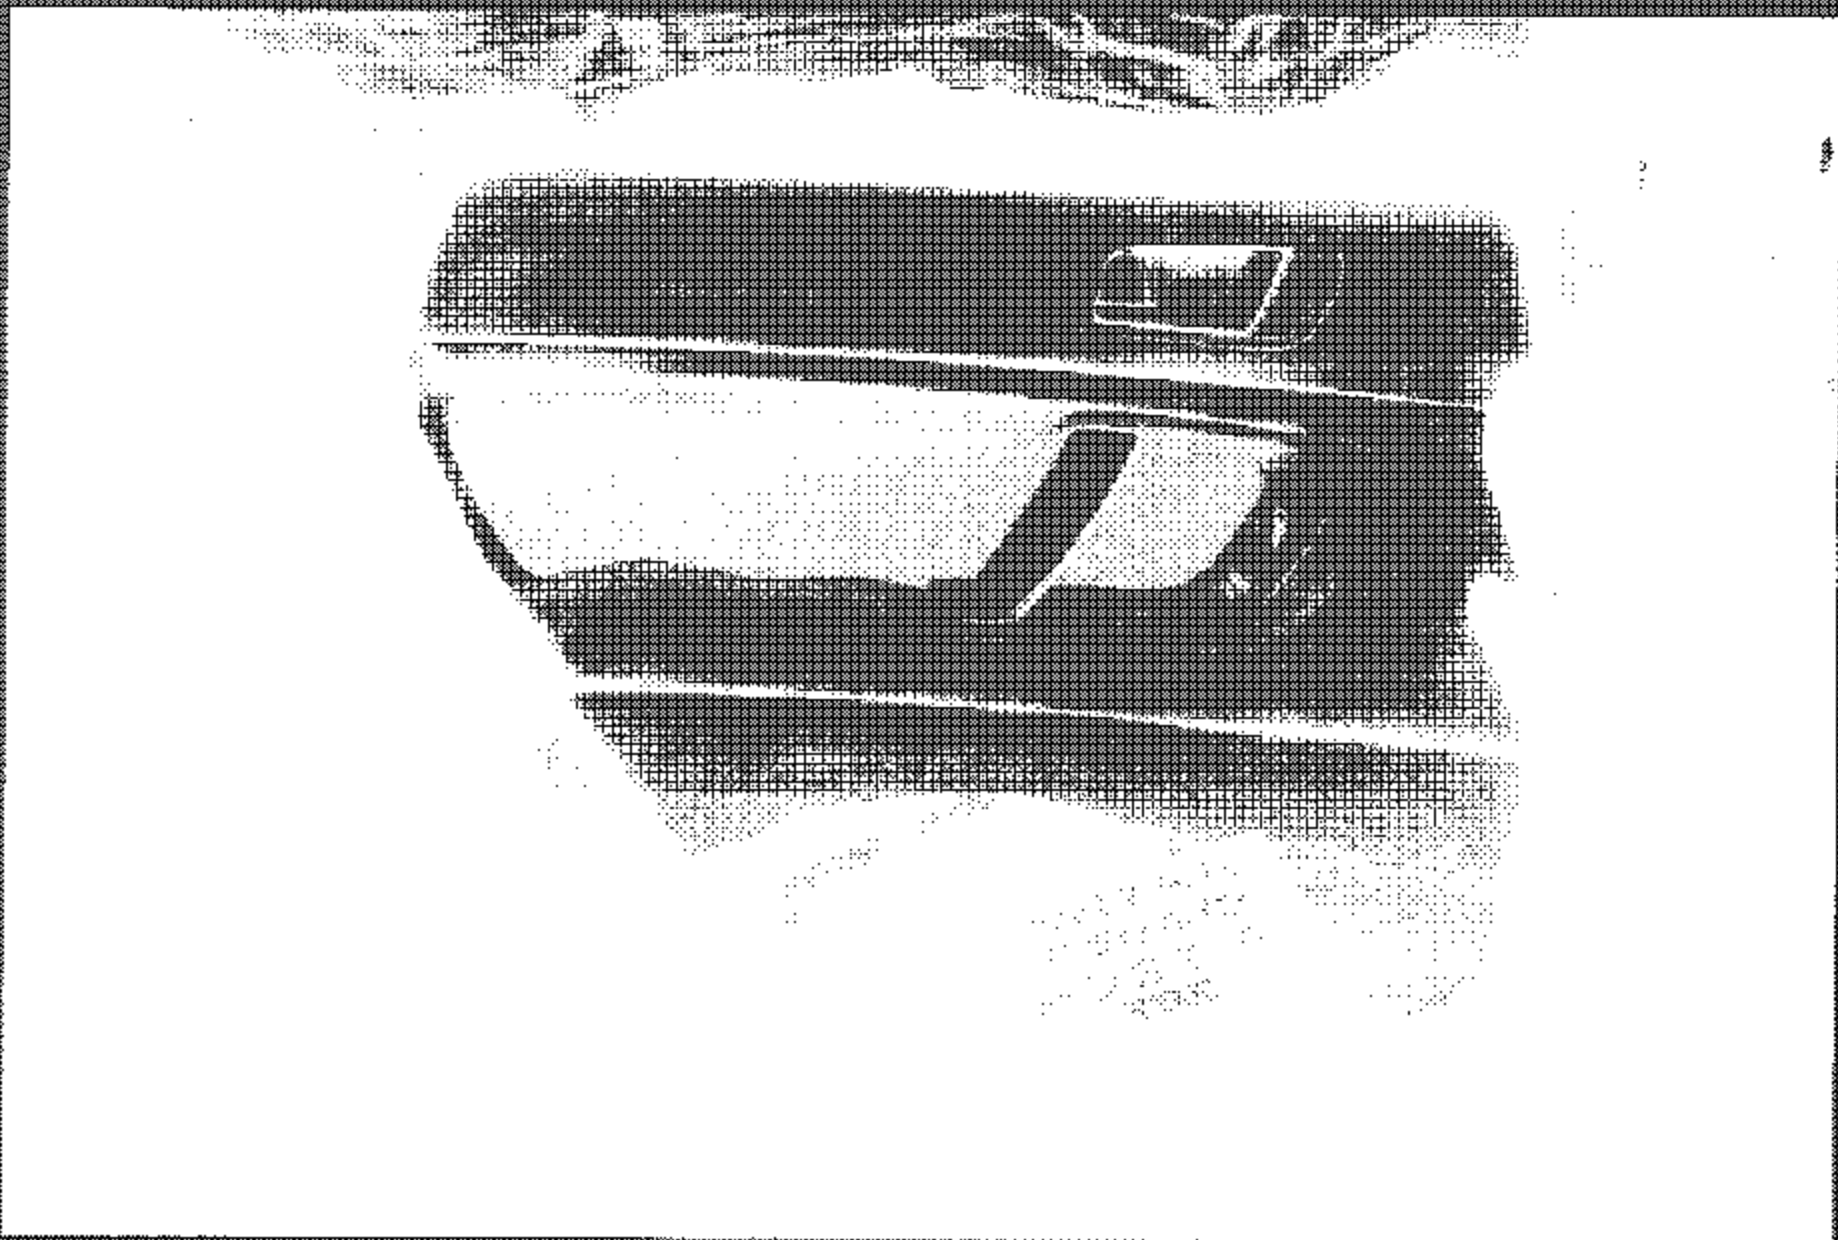
Figure A-41. Post-Test Interior of Rear Panel Showing SOI Impact Location

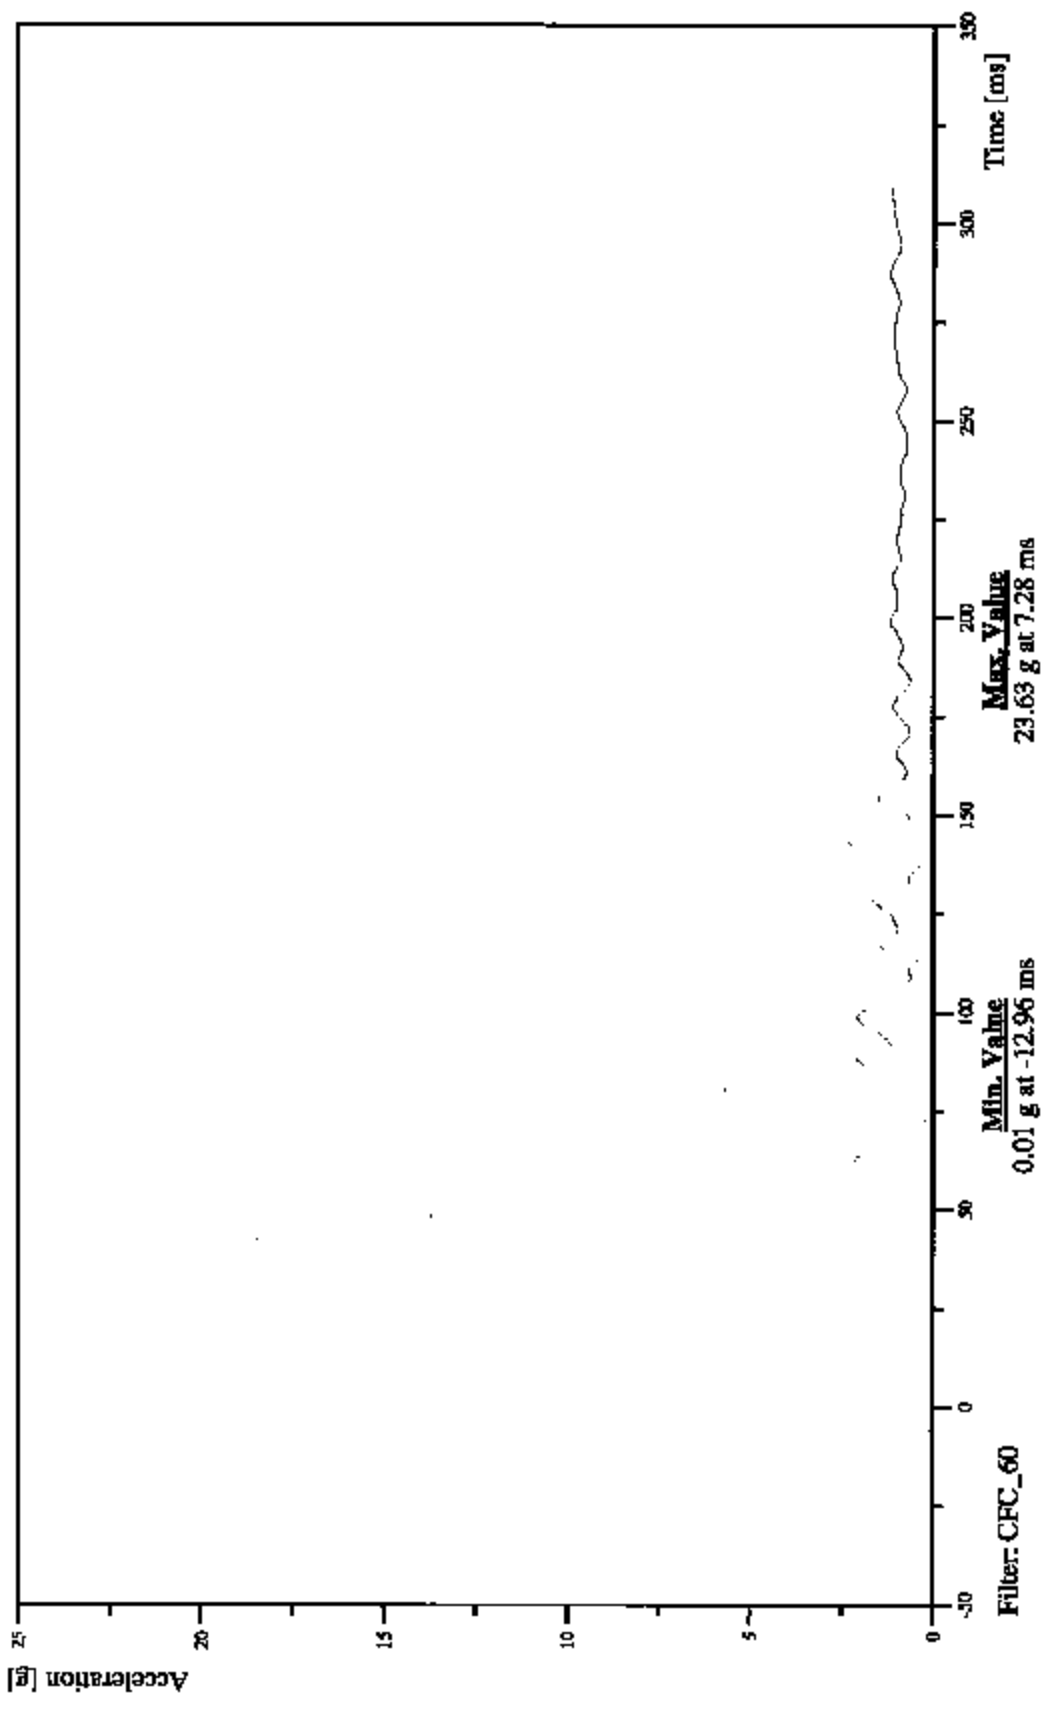
48/24 kph 90 Degree Side Impact (MDB) into Left Side of 2005 Subaru Legacy
Time: 11:50
REAR FLOORPAN ABOVE AXLE (X) ACCELERATION VS TIME (#3)

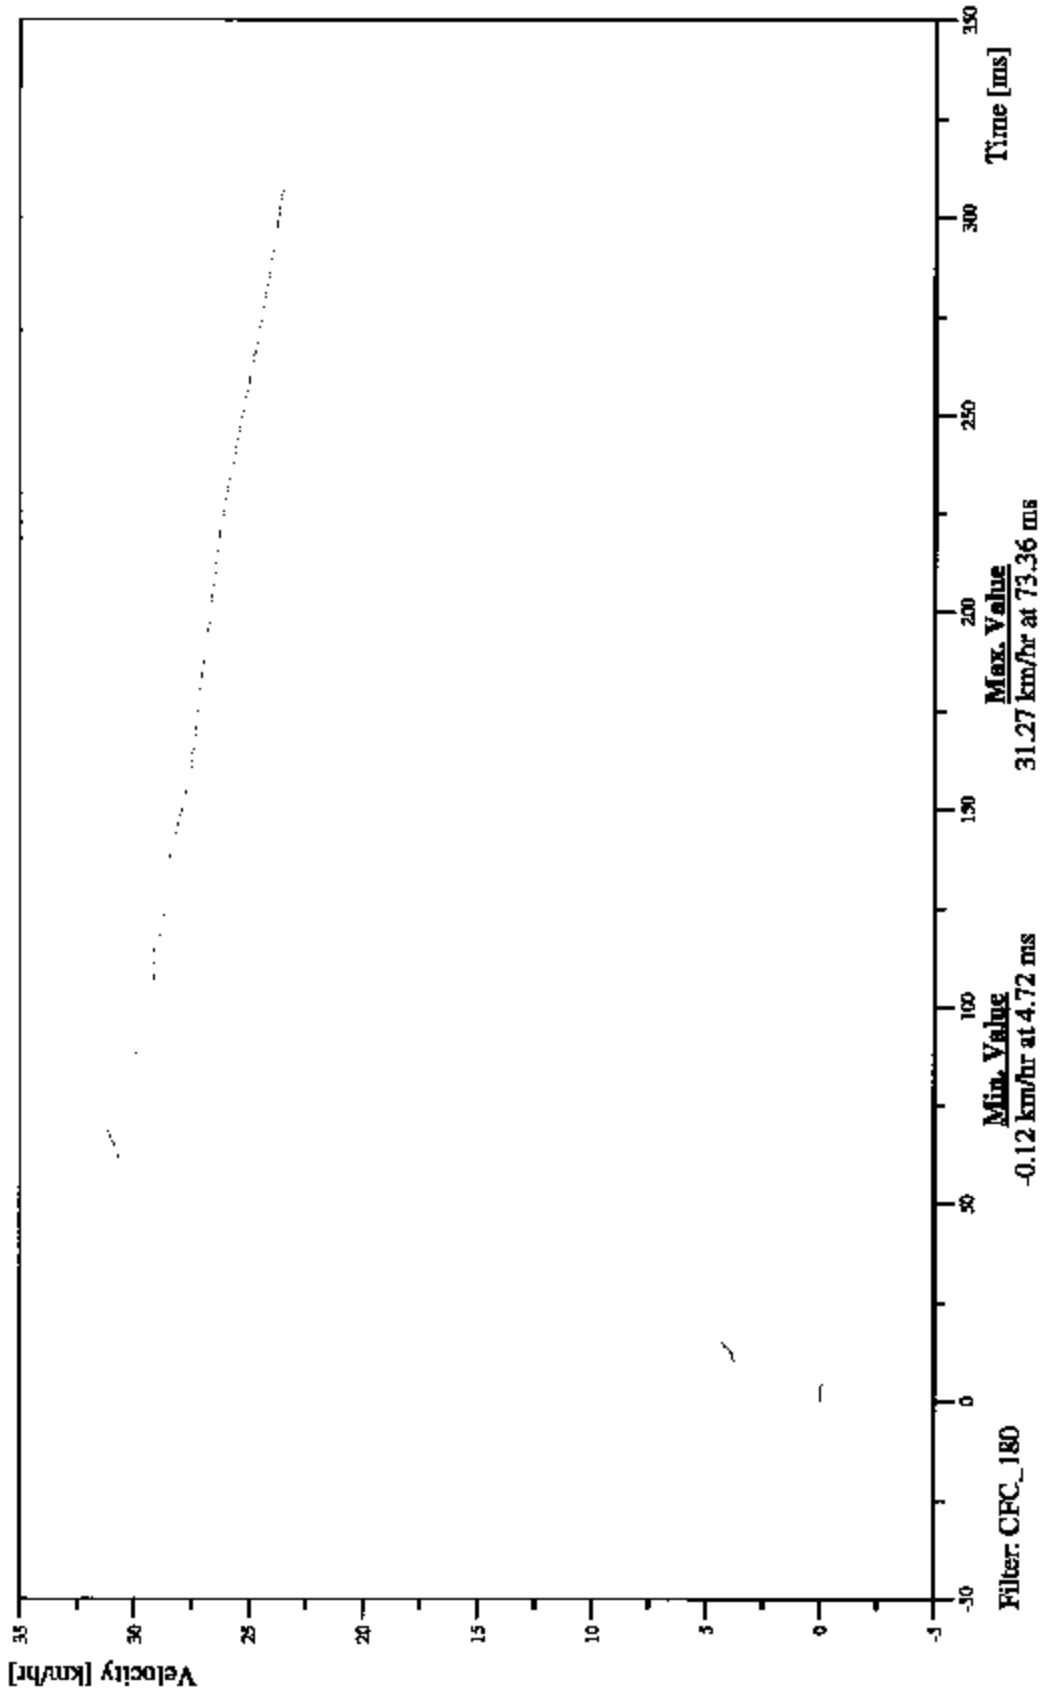
48/24 kph 90 Degree Side Impact (MDB) into Left Side of 2005 Subaru Legacy
Time: 11:01
REAR FLOORPAN ABOVE AXLE (Z) ACCELERATION VS TIME (#3)

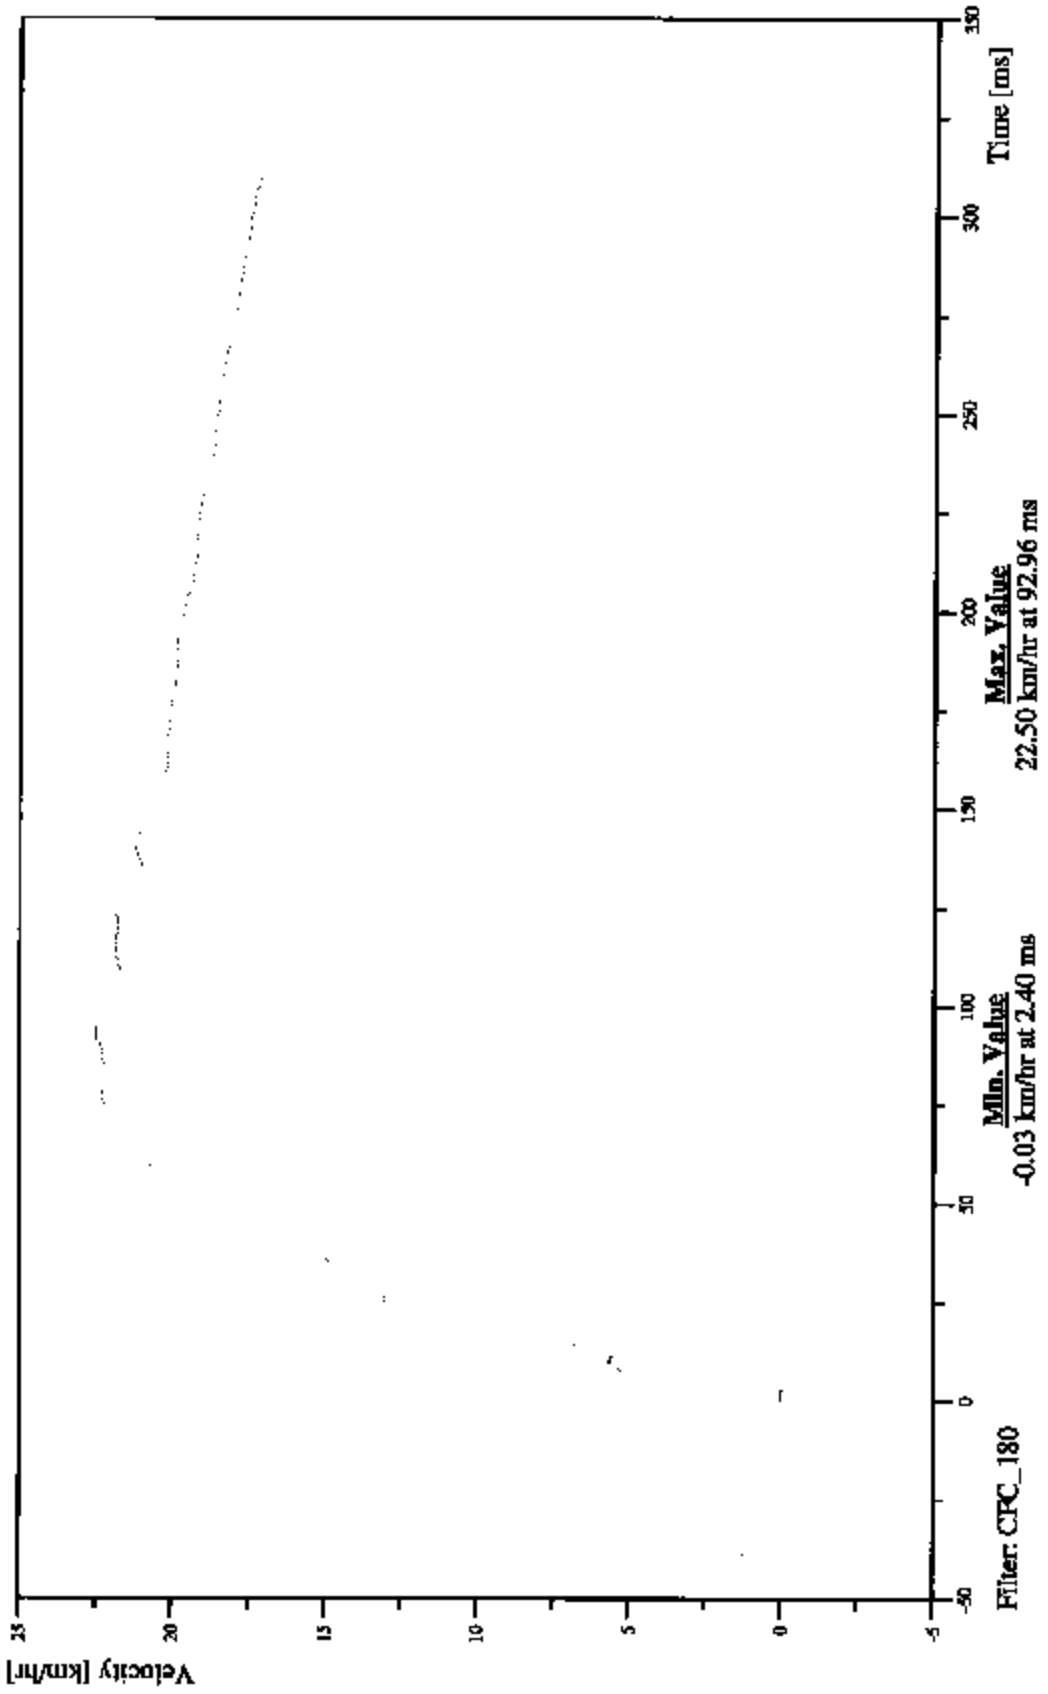
48/24 kph 90 Degree Side Impact (MDB) into Left Side of 2005 Subaru Legacy
RIGHT REAR OCCUPANT COMPARTMENT (Y) ACCELERATION VS. TIME (#7)

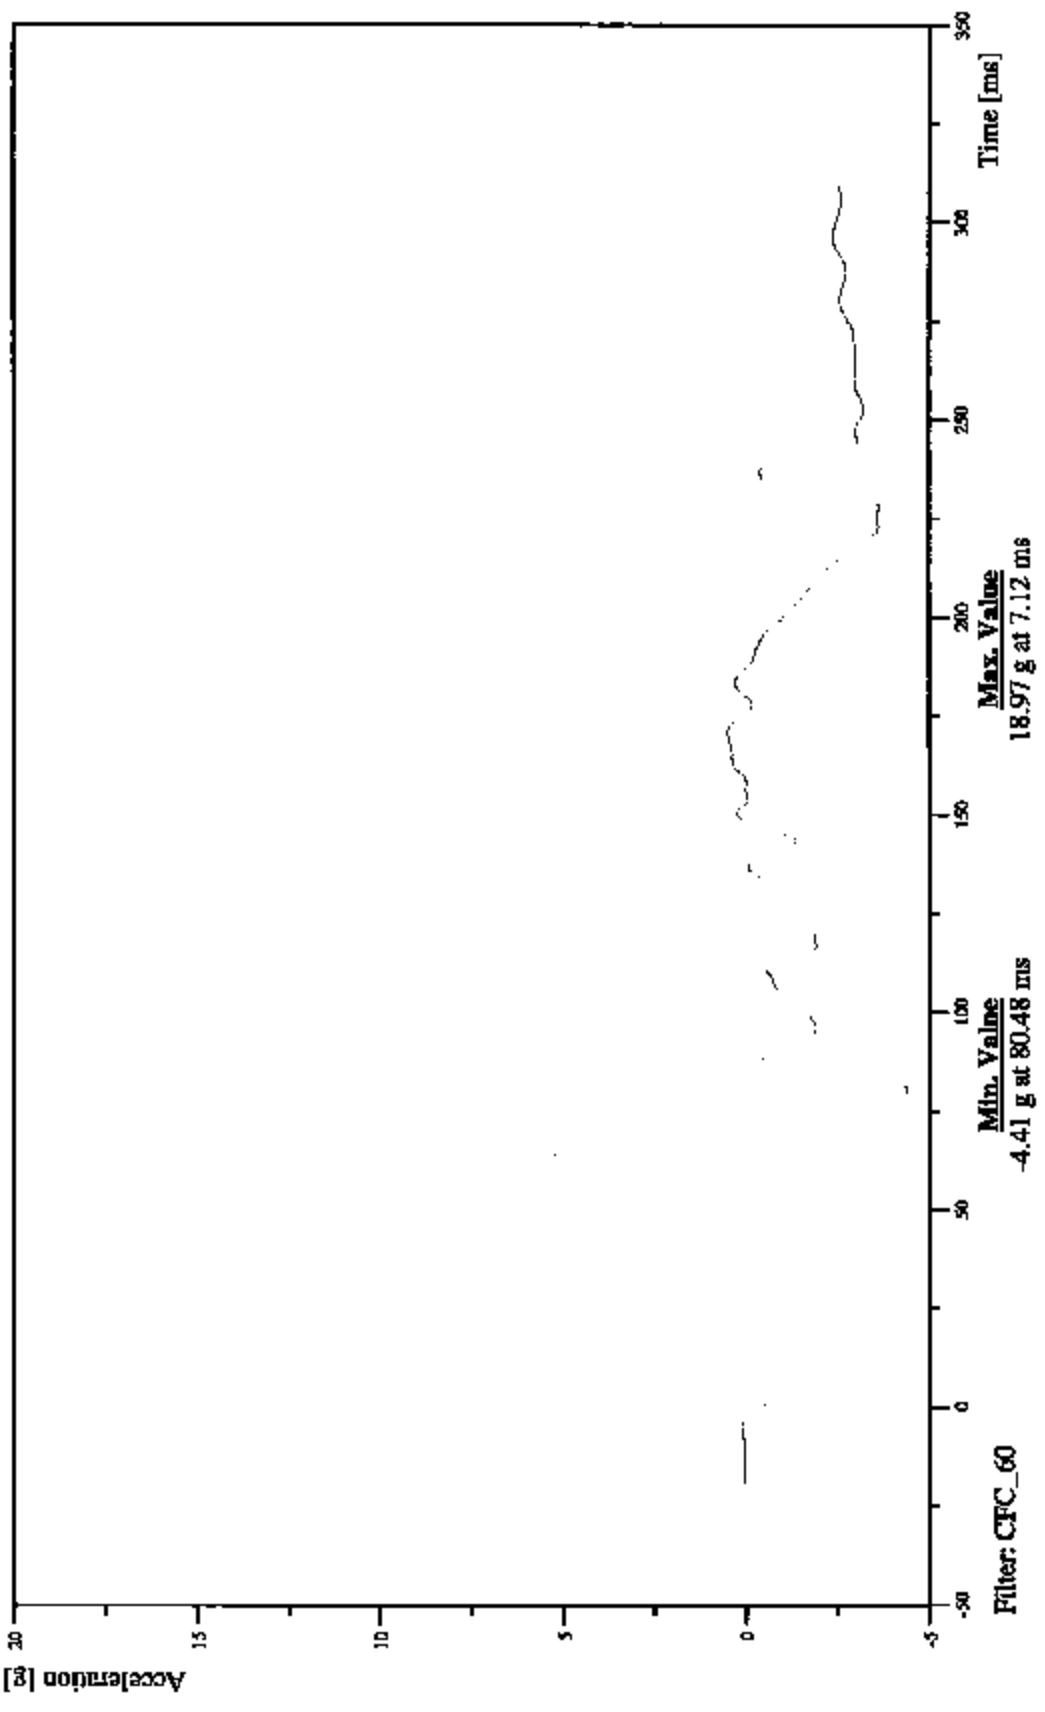
48/24 kph 90 Degree Side Impact (MDB) into Left Side of 2005 Subaru Legacy
Time: 04/07/2005
RIGHT REAR OCCUPANT COMPARTMENT (Y) VELOCITY VS TIME (#7)

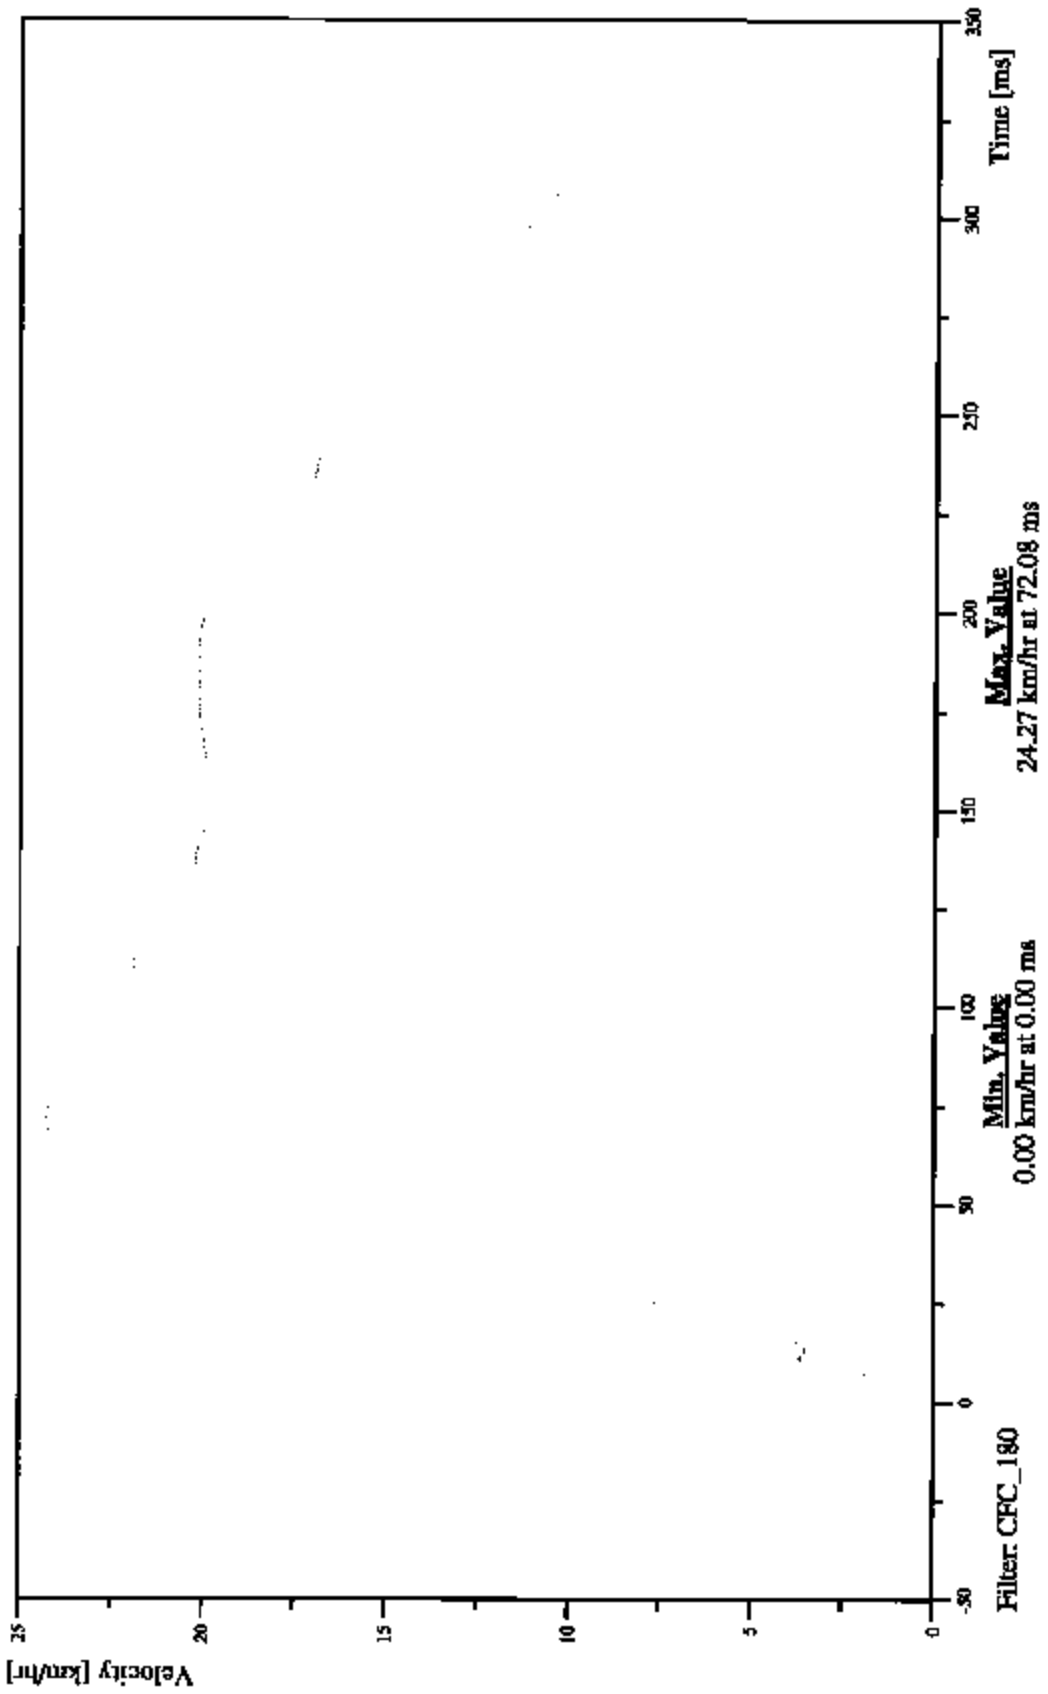
48/24 kph 90 Degree Side Impact (MDB) into Left Side of 2005 Subaru Legacy
Time: 04/07/2005
LEFT LOWER A-POST. ACCELERATION VS TIME (#14)

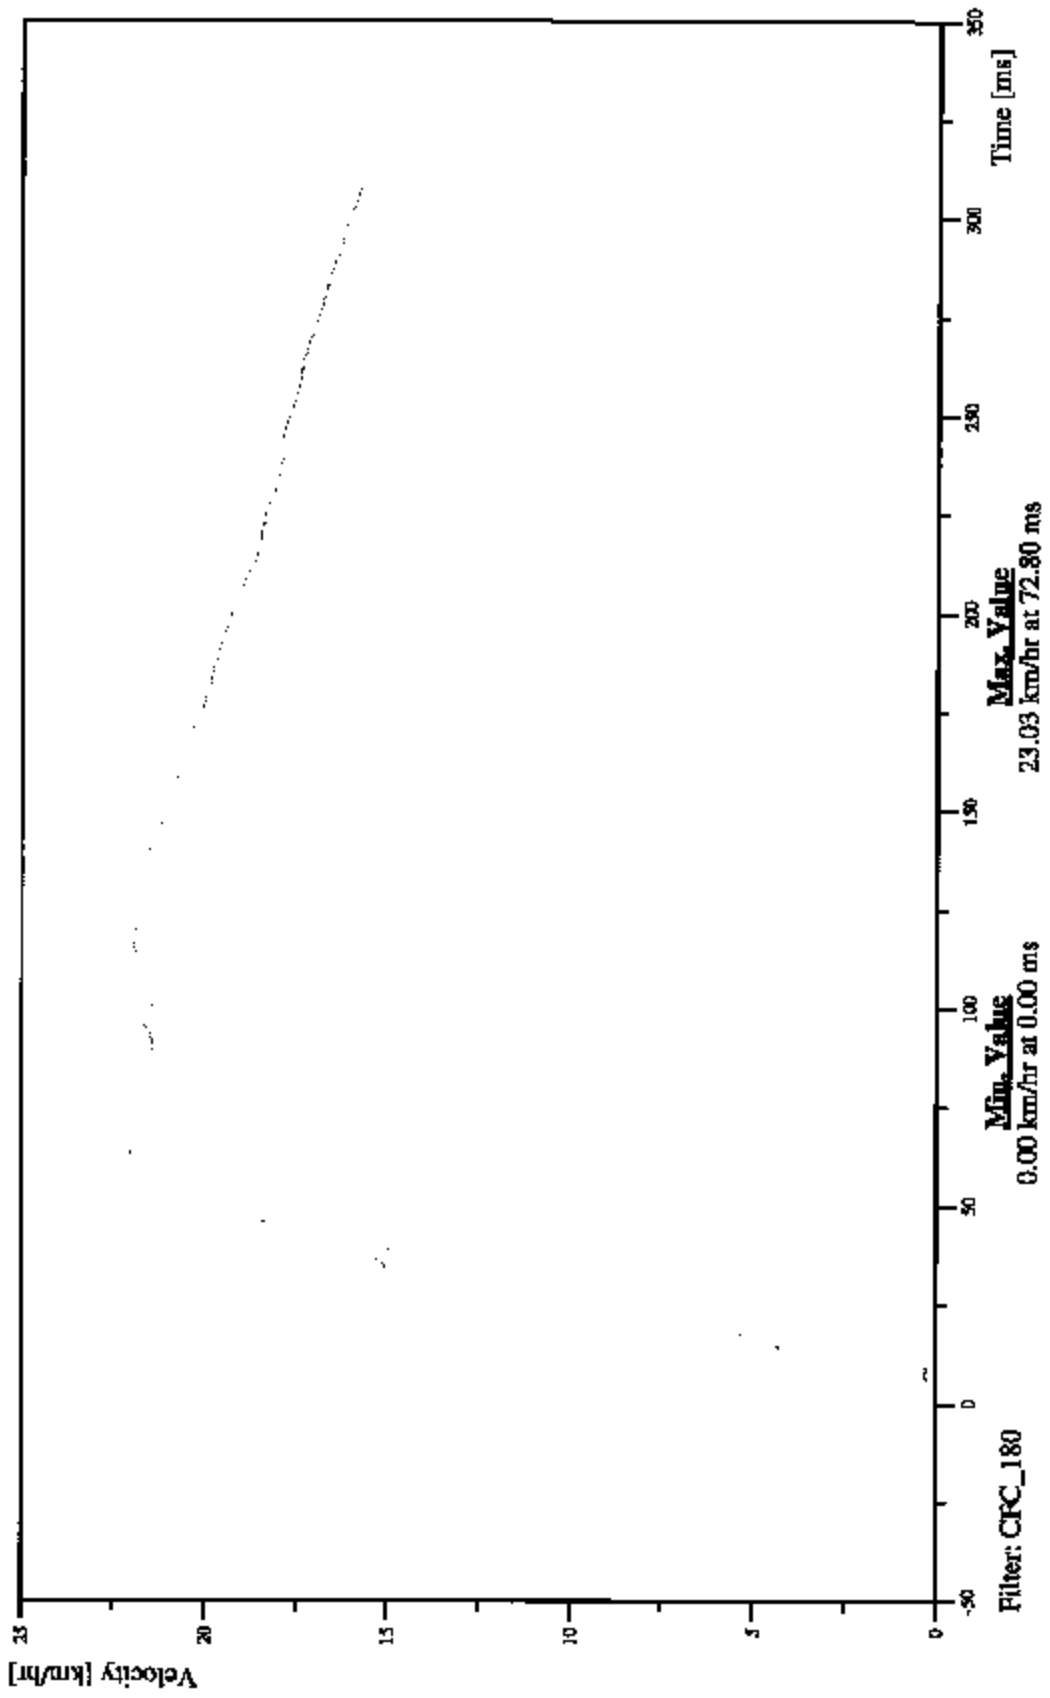
48/24 kph 90 Degree Side Impact (MDB) into Left Side of 2005 Subaru Legacy
Time: 11:01
VEHICLE CENTER OF GRAVITY (Z) ACCELERATION VS TIME (#18)
